ANNUAL REPORT FOR 2004

Key Branch Mitigation Site
Anson County
WBS Element 34398.4.1
TIP No. R-2239WM

Prepared By:
Office of Natural Environment & Roadside Environmental Unit
North Carolina Department of Transportation
March 2005

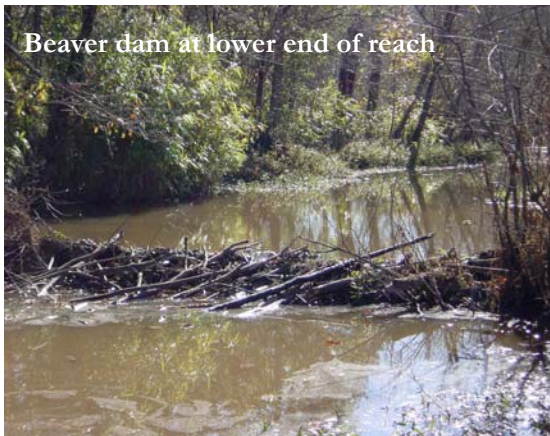
- ◆ A beaver impoundment (approximately 150 feet from the end of the site) has caused a large pond to form at the lower end of the reach. The impoundment has also

caused water to back up throughout the reach. The high water level has resulted in the stream not functioning according to designs.

Beaver dam at lower end of reach

Based on the overall conclusions of monitoring, the Key Branch Mitigation Site has met the required stream monitoring protocols for the first formal year of monitoring. Higher than normal water levels exist due to a beaver impoundment at the lower end of the reach; however, NCDOT is in contact with the United States Department of Agriculture (USDA) to remove the impoundment and relocate the beavers.

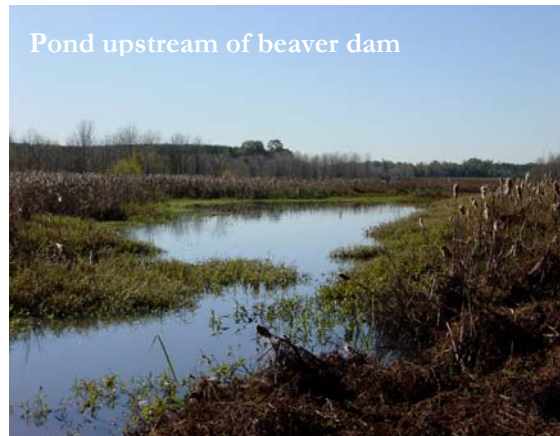
Pond upstream of beaver dam

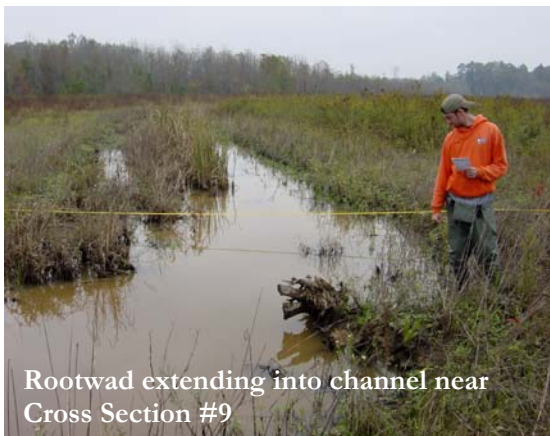
- ◆ Numerous live stakes were noted within the wetted parameter of the channel. This is a result of the high water levels at the site.
- ◆ Erosion along the stream banks has caused rootwad revetments to extend into the center of the channel. Increased establishment of vegetation should stabilize the banks and cause less erosion.

Rootwad extending into channel near
Cross Section #9

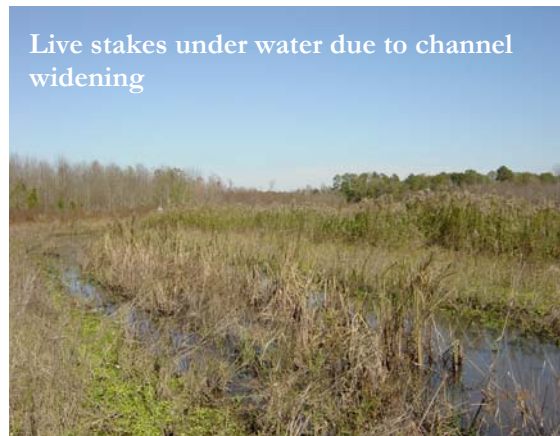
Live stakes under water due to channel
widening
